CITATION: *Inquest into the death of Brody Roy Wauchope-Dirdi*
[2021] NTLC 033

CATCHWORDS: **Electrocution of 11 year old boy at a home in a remote Aboriginal community, roof live with 240 volts, caused by faulty Power and Water Corporation connection to residence, no earthing of electrical connection and metal roof, no maintenance or inspection over 25 years**

BRODY ROY WAUCHOPE-DIRDI

FINDINGS

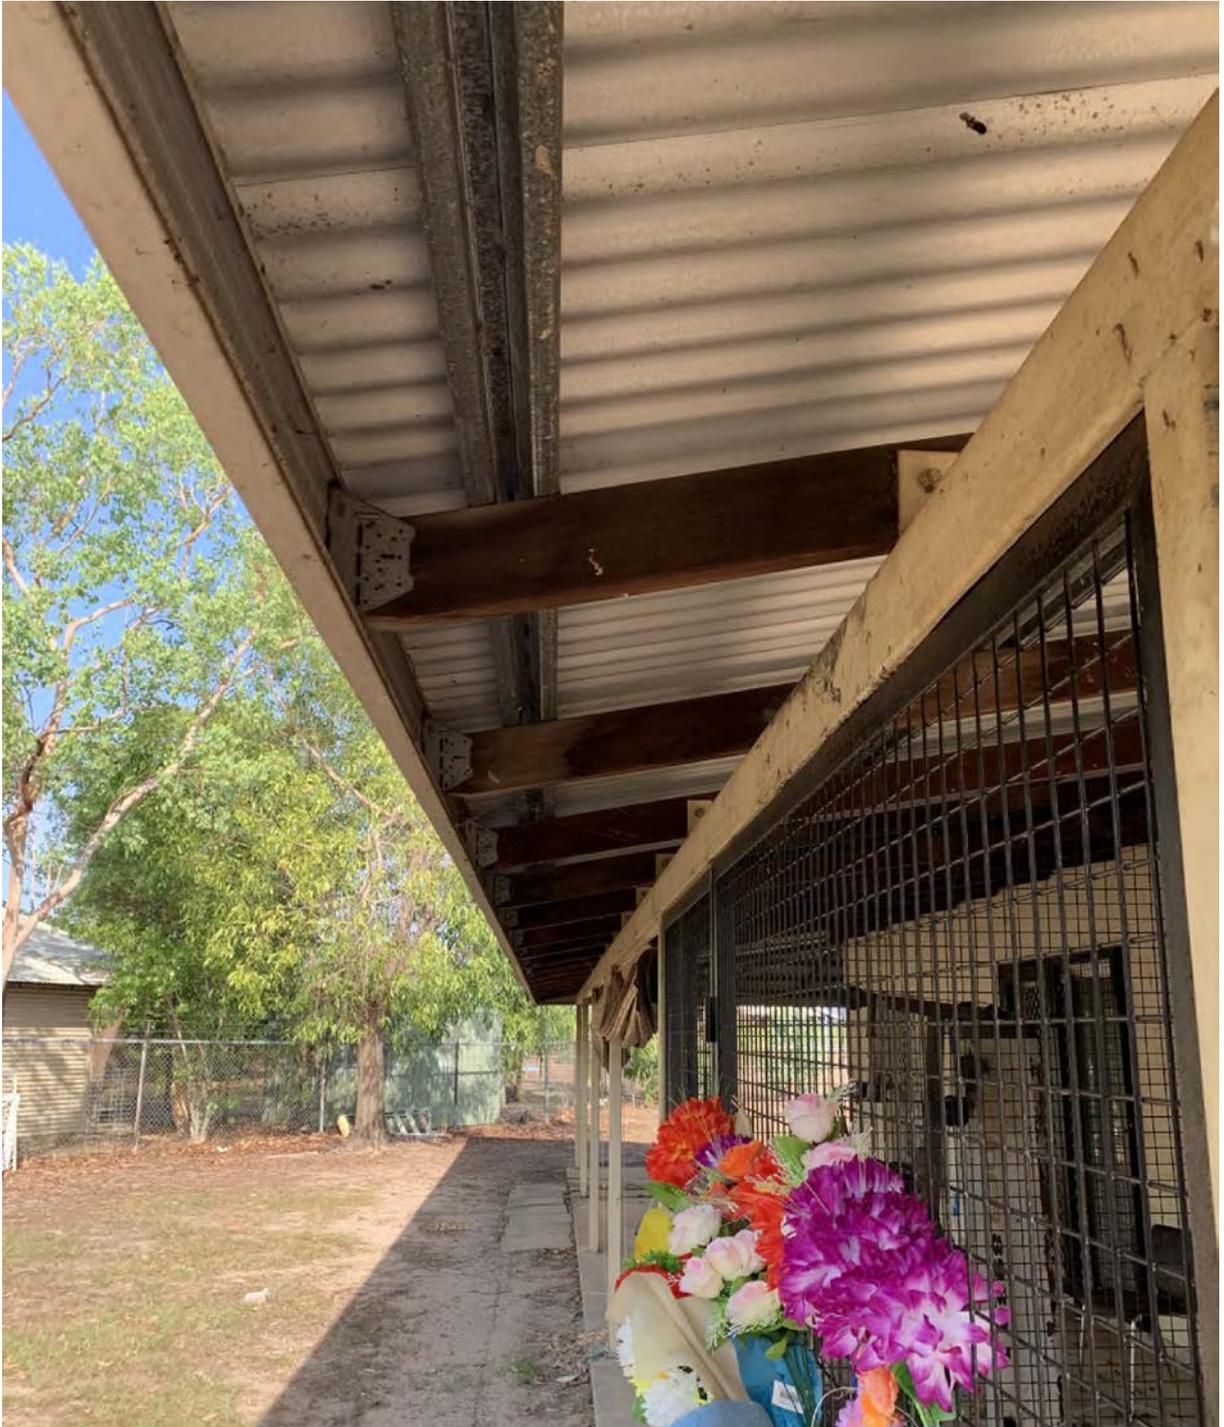
4. The house has verandas on two sides. The verandas have steel poles supporting a steel beam upon which the rafters rest that support the iron roof. At the end of one of the verandas outside the room in which Kelly

slept was an area enclosed in steel mesh. On either side it extended up to the rafters but on the outside of the veranda it extended only up to the steel beam. That left open the space above the beam and below the roof of about 200mm.

Figure 1. The veranda, posts, beam, the mesh and the 200mm gap between beam and iron roof

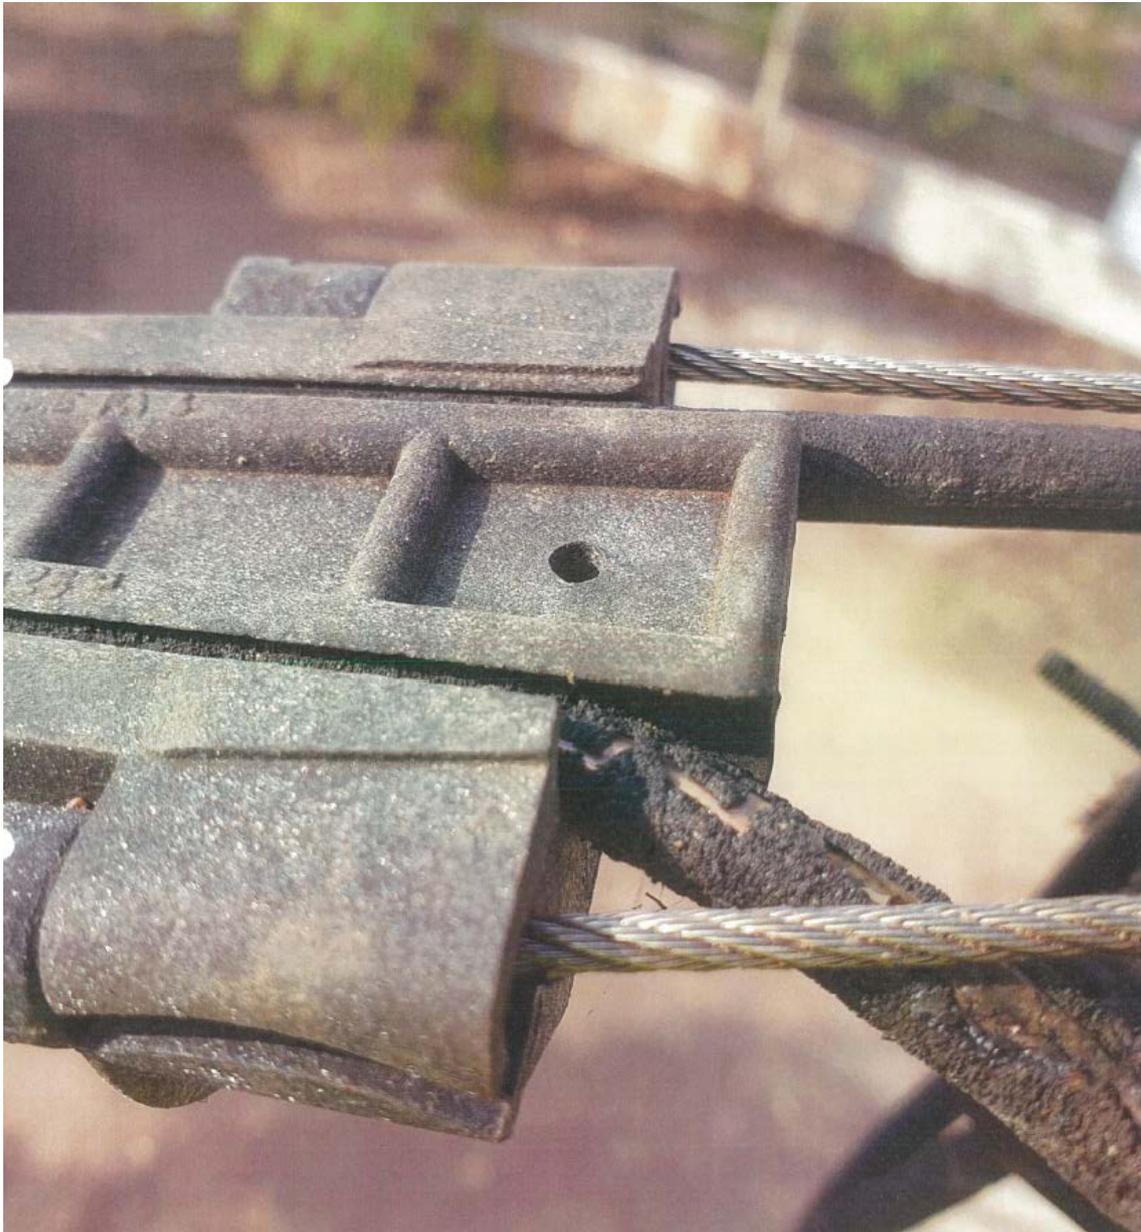
14. The insulation on the Power and Water service conductors (service lines) was degraded. The service conductors had not been shaped away from braided cables attaching the clamp to the metal gooseneck riser. The braided cable was also in direct contact with the metal of the gooseneck riser

attached to the premises. That was a consequence of the insulated collar being installed below rather than above the mounting disk.

Figure 2. Showing degraded insulation and contact with steel braided cable

“In this case, it is apparent that the primary fault in this residence that permitted the roof to be energised to 240Vac was the poorly maintained supply authority aerial service conductors.

The photos appear to show badly UV degraded insulation on the service conductors to a degree where the insulation failed to

adequately separate energised conductors from directly contacting metallic support structures, which in turn were in direct contact with the iron roof. That fault may have occurred months or even years ago, without detection or inspection.

45. I **recommend** that Power and Water Corporation ensure that all infrastructure including service conductors and clamps is subject to a system of regular inspection and maintenance and that the inspection and maintenance be recorded and audited.

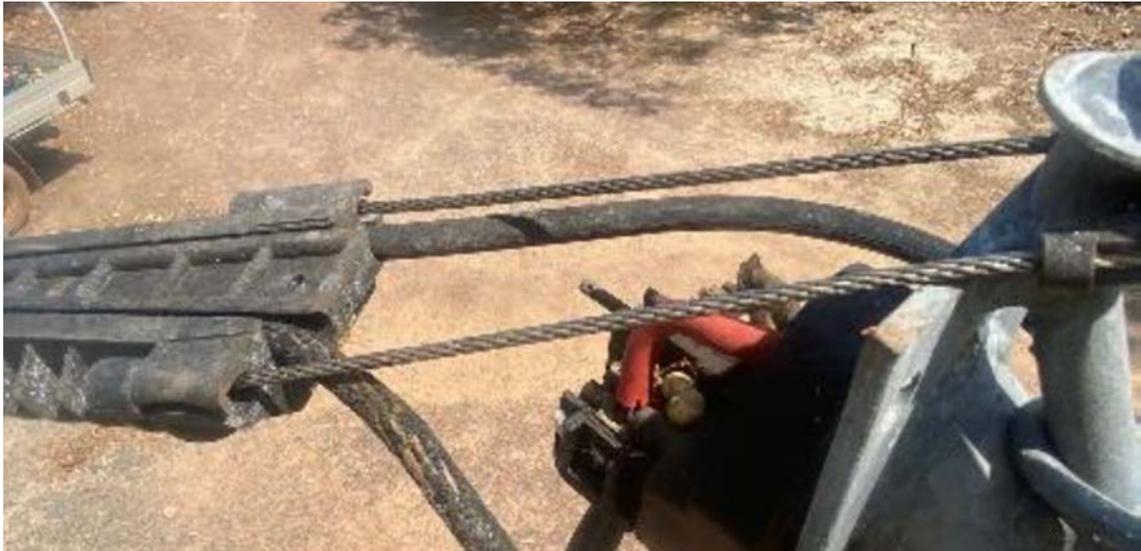
Figure 3. Showing clamp, degraded insulation and service conductors not shaped away from metal contact points

d. The standard drawings for customer attachment were being amended to emphasise conductor-shaping to achieve maximum clearance.

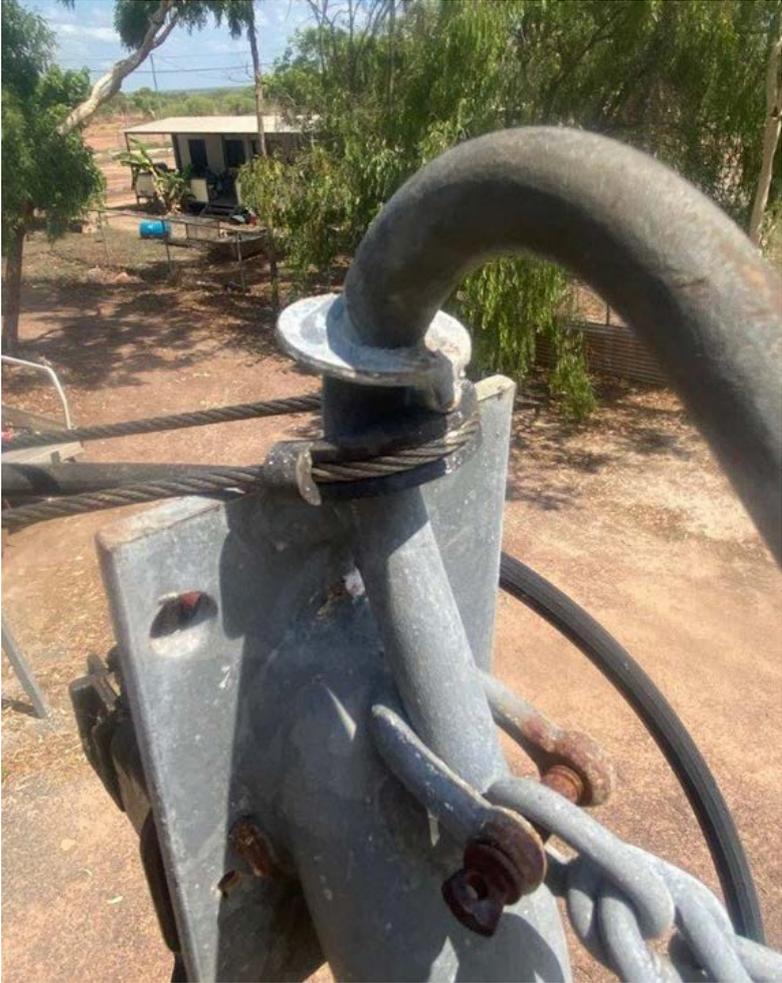
Figure 4. Showing braided cable touching plate on riser and insulated collar positioned below mounting disk

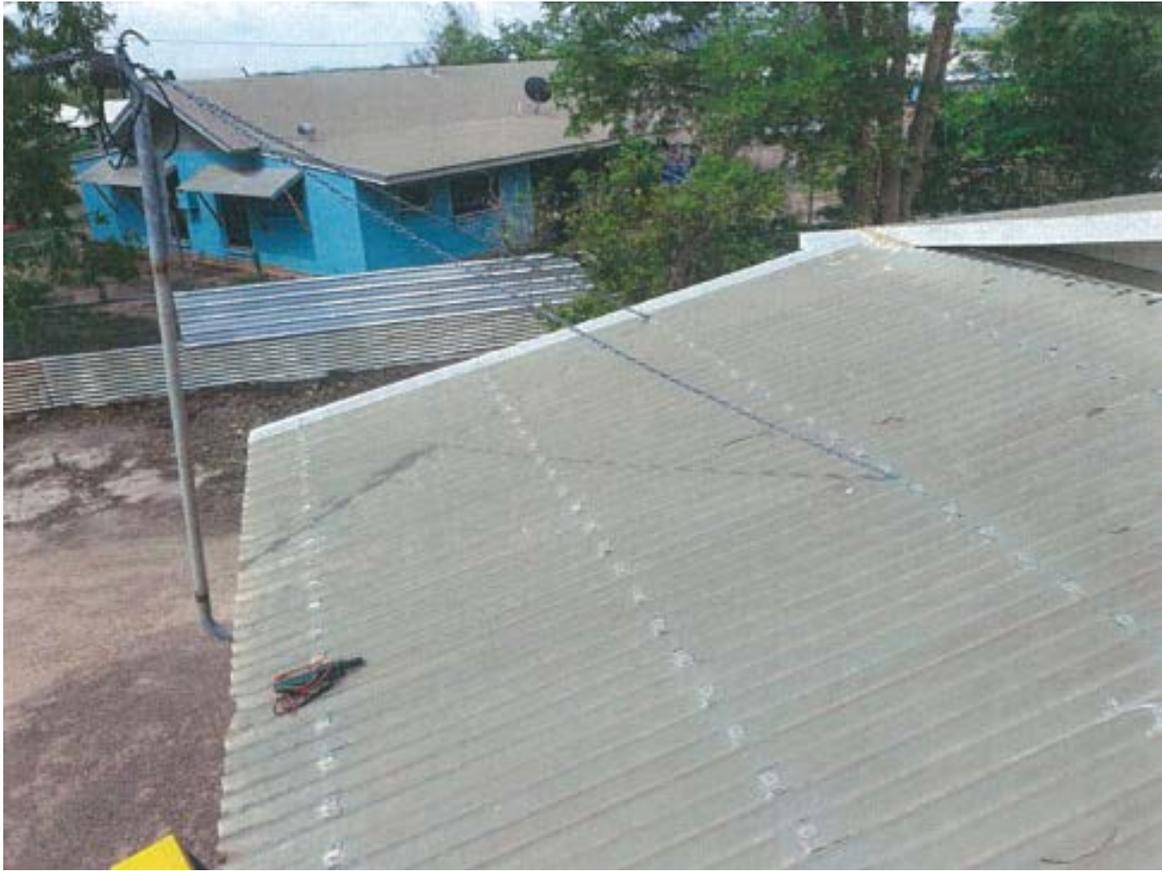
Figure 5. Showing riser and support chains connecting to iron roof

required to be earthed as is the metal roof. That is the owner's responsibility also. However, neither were earthed and the roof sat on wooden rafters insulating it from the rest of the house.

16. If the riser pole or roof had have been earthed, a short would have been created and the pole fuse would have blown when the insulation degraded to the point where the braided cable and pole became electrified. However without an earth, the pole and roof remained live with 240 volts. It is not known for how long that was the case.

As the roof was electrically insulated from the mass of earth by the timber roof bearers, the roof was therefore permitted to remain energised at 240Vac potential without rupturing the service fuse (pole fuse).

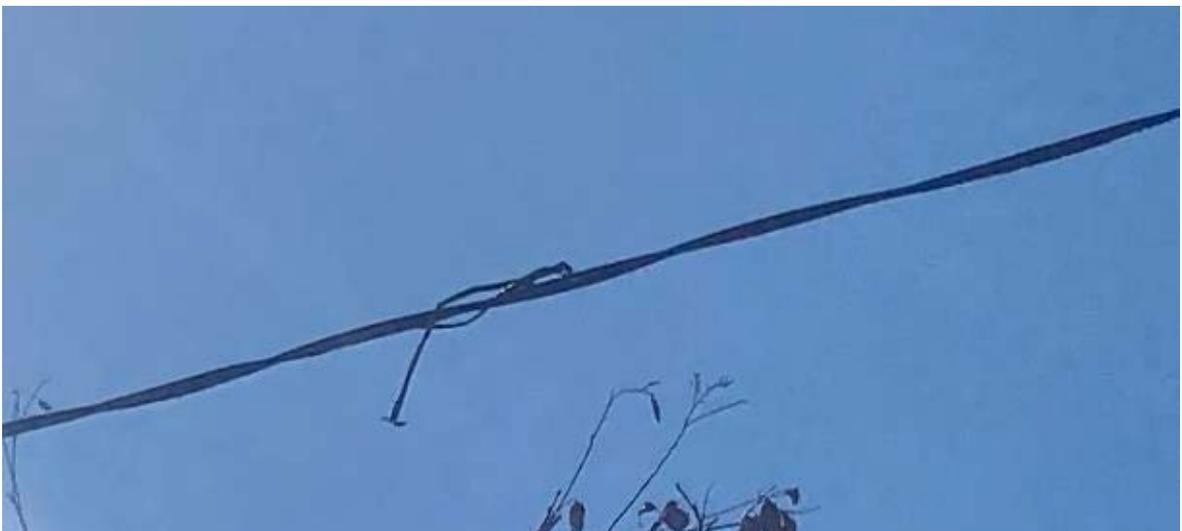
Figure 6. Showing insulation degradation on the service conductor

- b. Develop an action plan to inspect overhead electrical supply services subdivisions commissioned between 1995 and 1998 for regulated centres.
28. The reason for the second of those requirements related to Power and Water's belief that the degraded insulation was from a batch of insulated conductor wires used during that period. That was the batch from which the service conductor at Lot 548 originated.
