CITATION: *Inquest into the death of Benjamin Glen Watts* [2021] NTLC 013

BENJAMIN GLEN WATTS

ON: 8 MAY 2020

**AT: DARWIN CORRECTIONAL
CENTRE, HOLTZE**

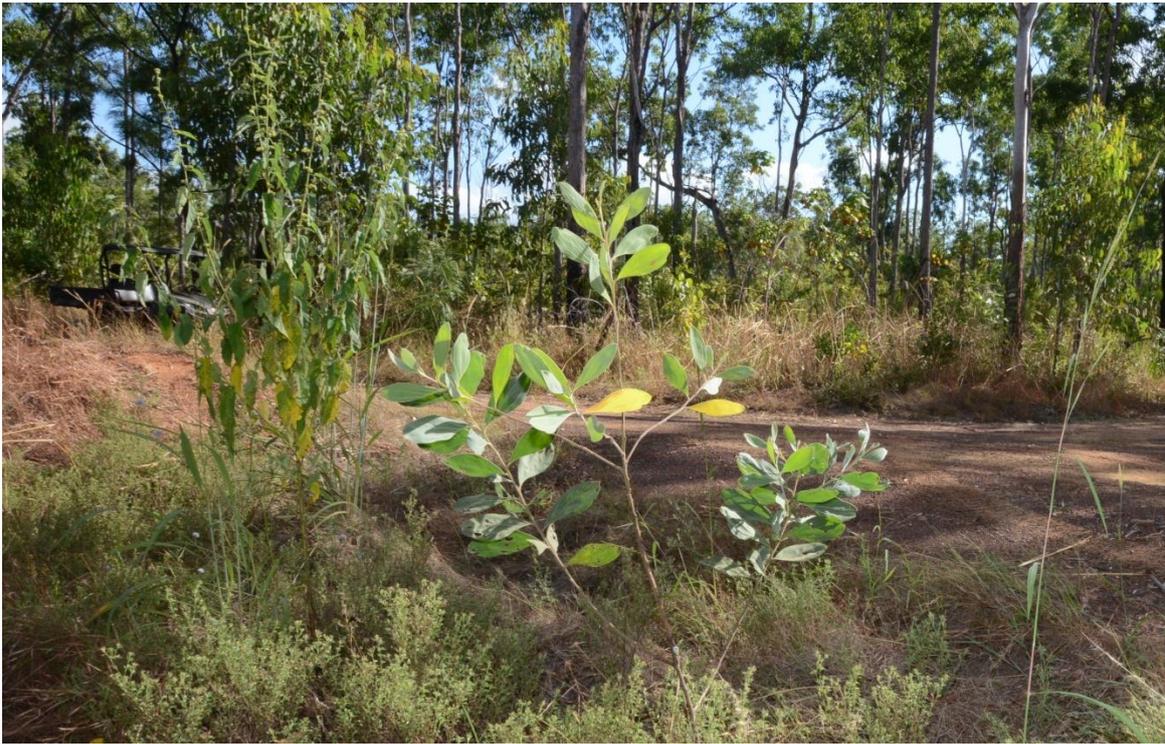
19. The other prisoners estimated they were travelling at about 30 kilometres an hour and thought he was travelling significantly faster (on one estimation, at twice their speed). He drove the ATV on the grassed area with a view to re-joining the main track. Unseen and disguised by grass was a 1.03 metre high dirt mound. His ATV hit the mound, the right hand side dug in and he and the ATV were launched into the air. Those in the Mule said that the ATV went so high it would have flown over them if they had been on that part of the track.

20. He was not wearing a seatbelt and was separated from the ATV either at the point where the ATV dug in or when it landed nose first. The evidence is that it landed front wheels first and then rotated and ended up on its wheels pointed back down the main track toward the oncoming Mule.

Photo showing mound on the left, now visible, with Polaris on its wheels in the background.

29. Many changes were made, the SOPs and SWMS were updated to reflect the manufacturers' warnings and recommendations, helmets were purchased and were required to be worn, the Mule was speed governed to 30 kilometres an hour and the Polaris decommissioned. The seat belts were coloured orange so as to be seen from a distance and the vehicles will not start until the seatbelt is engaged.

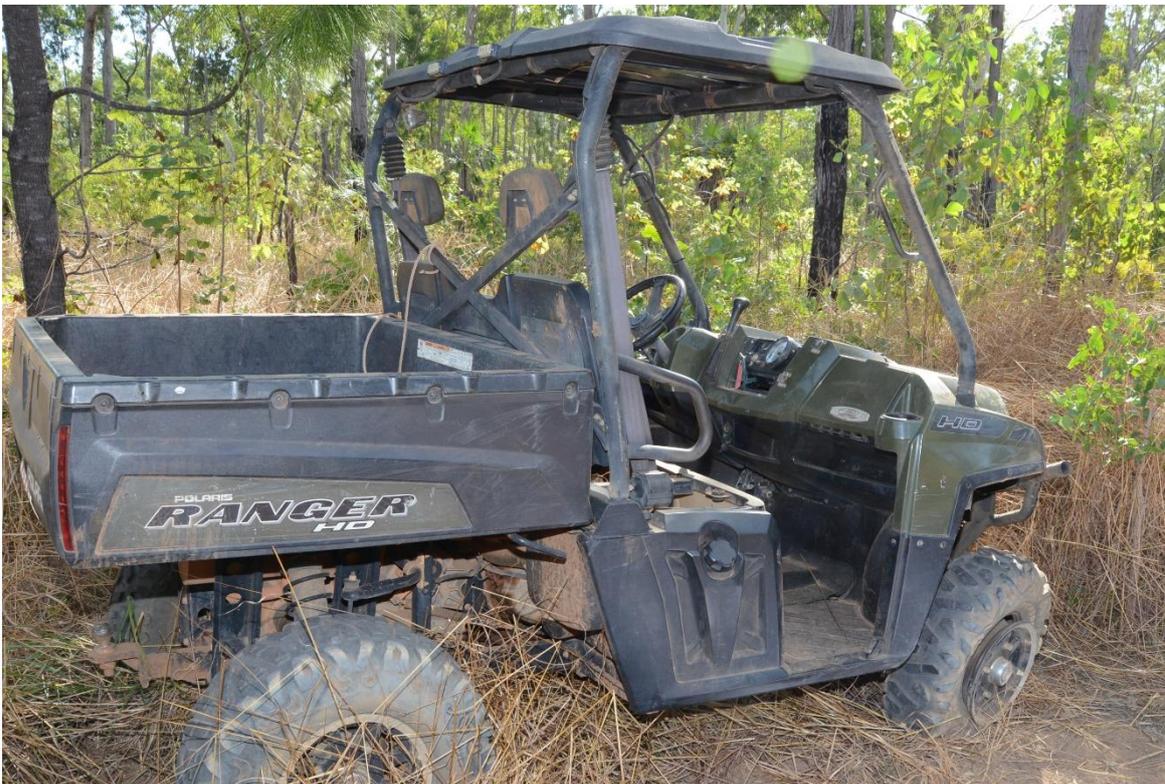
21. When Benny hit the ground it is likely that he suffered an atlanto-occipital dislocation fracture (separation of the spinal cord from the base of the skull) and moments later the Polaris landed on him, crushing his skull.

Polaris ATV near where it landed on its wheels (after it was lifted off the deceased).
